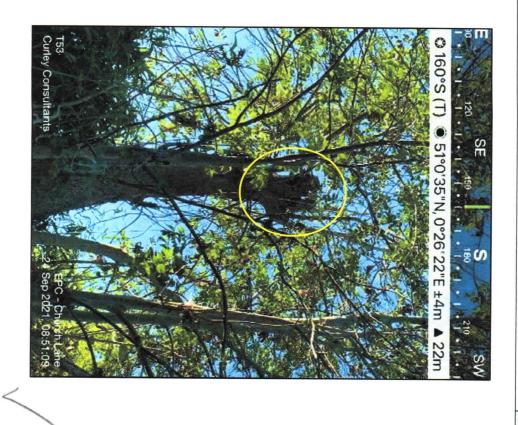
P19

T53: Ash: Extensive decay at the top of the stem, highlighted in yellow
